REPORT: FE-03-97

RAILROAD: Norfolk Southern Railroad (NS)

LOCATION: Macon, Georgia

PROBABLE CAUSE: The Carman did not remain clear of moving equipment.

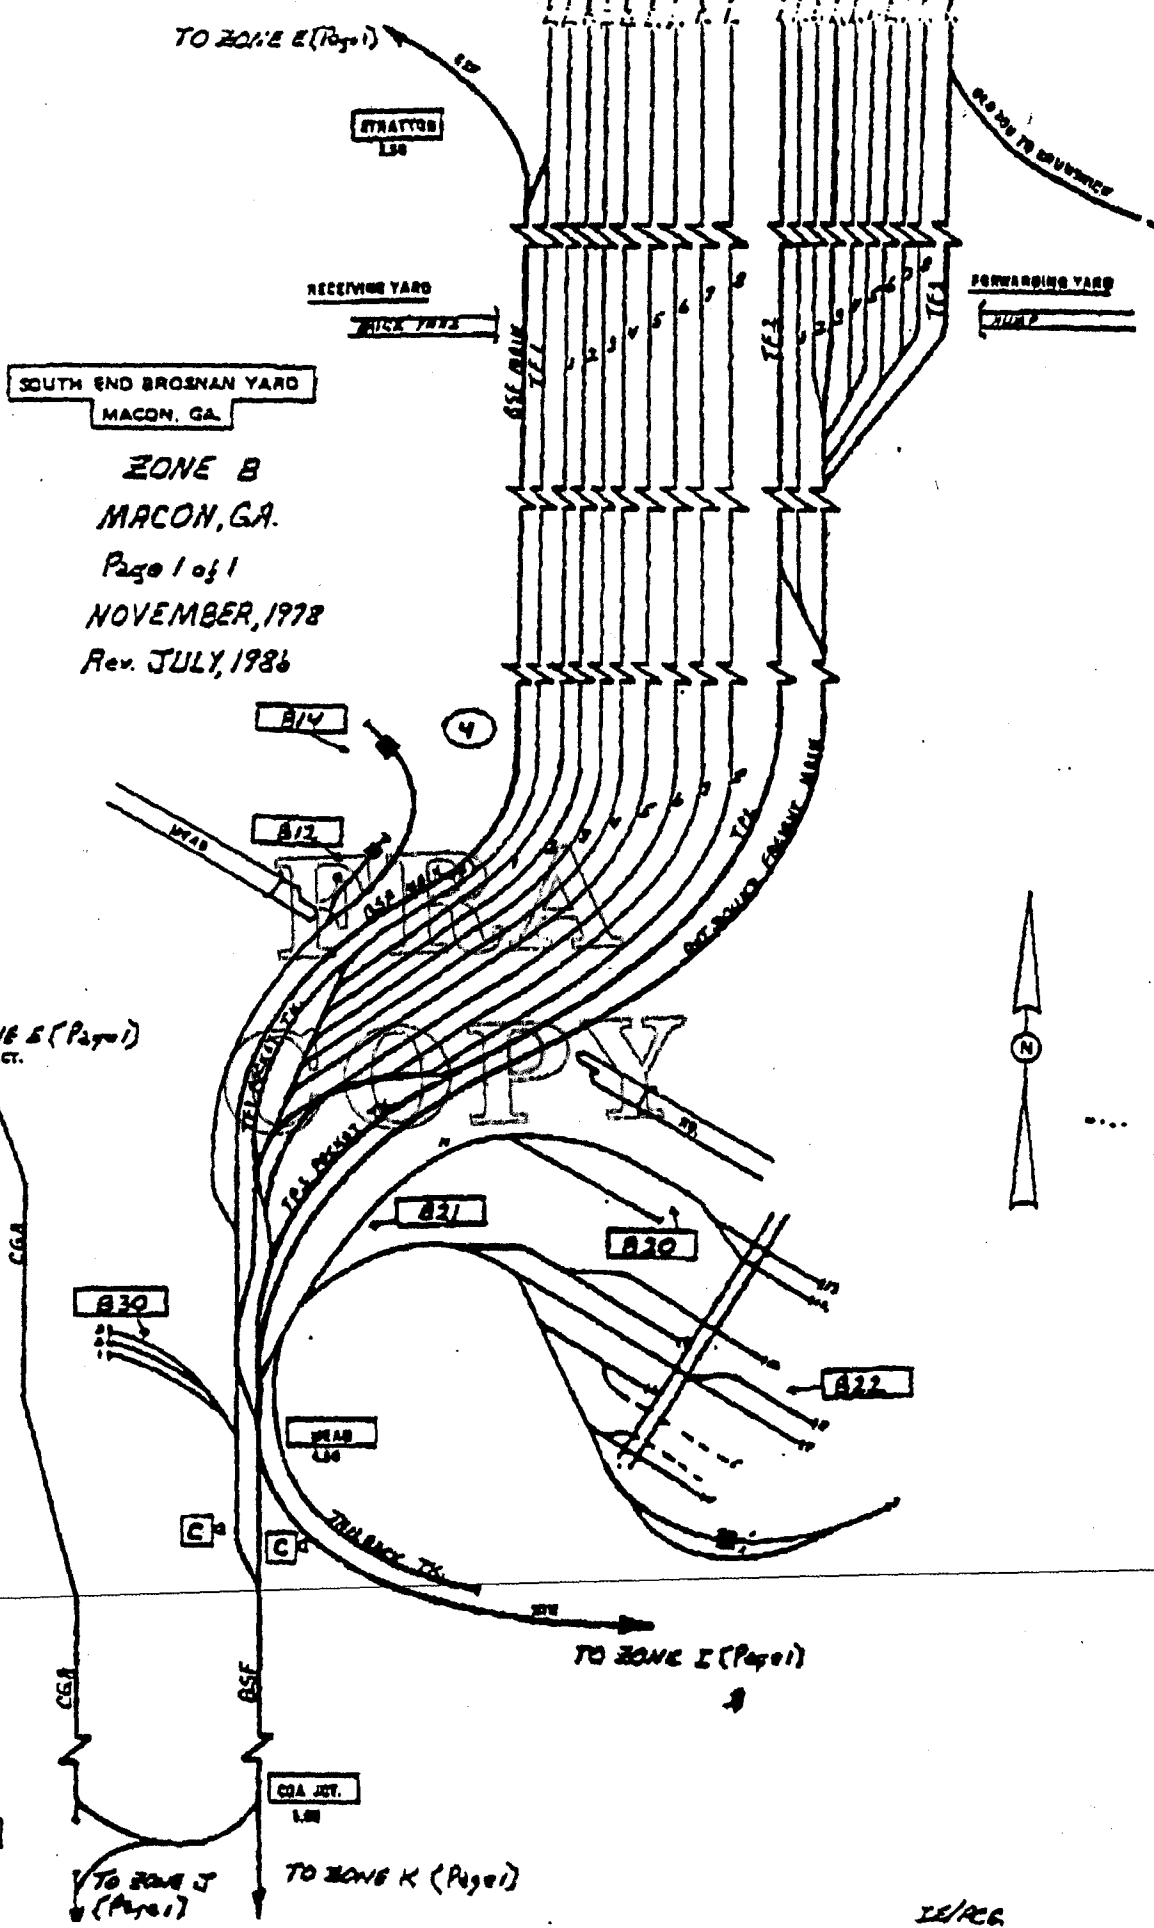
As the Carman was standing near the switch between Tracks Nos. 2 and 3, waiting for the locomotives of Train No. G-25 to pull southward out of the track, the locomotives of Train No. M-98 were passing him, moving northward on Track No. 1. For an undetermined reason, the Carman apparently fouled Track No. 1 and was struck by the locomotives of Train No. M-98 as they moved northward. The body of the Carman was discovered by the Crew Members of Train No. G-09 as the train pulled southward out of Track No. 2 at approximately 6:55 a.m., and they notified the Main Tower of their discovery via radio. There were no eye witnesses to the accident.

The Carman was wearing layered clothing with a stocking-type cap and a hooded sweatshirt at the time of the accident. His outer clothing was dark in color. It is unknown if the stocking cap and hooded sweatshirt he was wearing at the time had reduced his ability to hear. He also had gloves and a radio with him. His gloves and radio were found in the gage of the track north of the point of impact. His transected body was found approximately 191 feet north of the switch to Tracks Nos. 2 and 3. His upper torso was found in the gage of Track No. 1, while his lower portion was found outside the gage of the east rail.

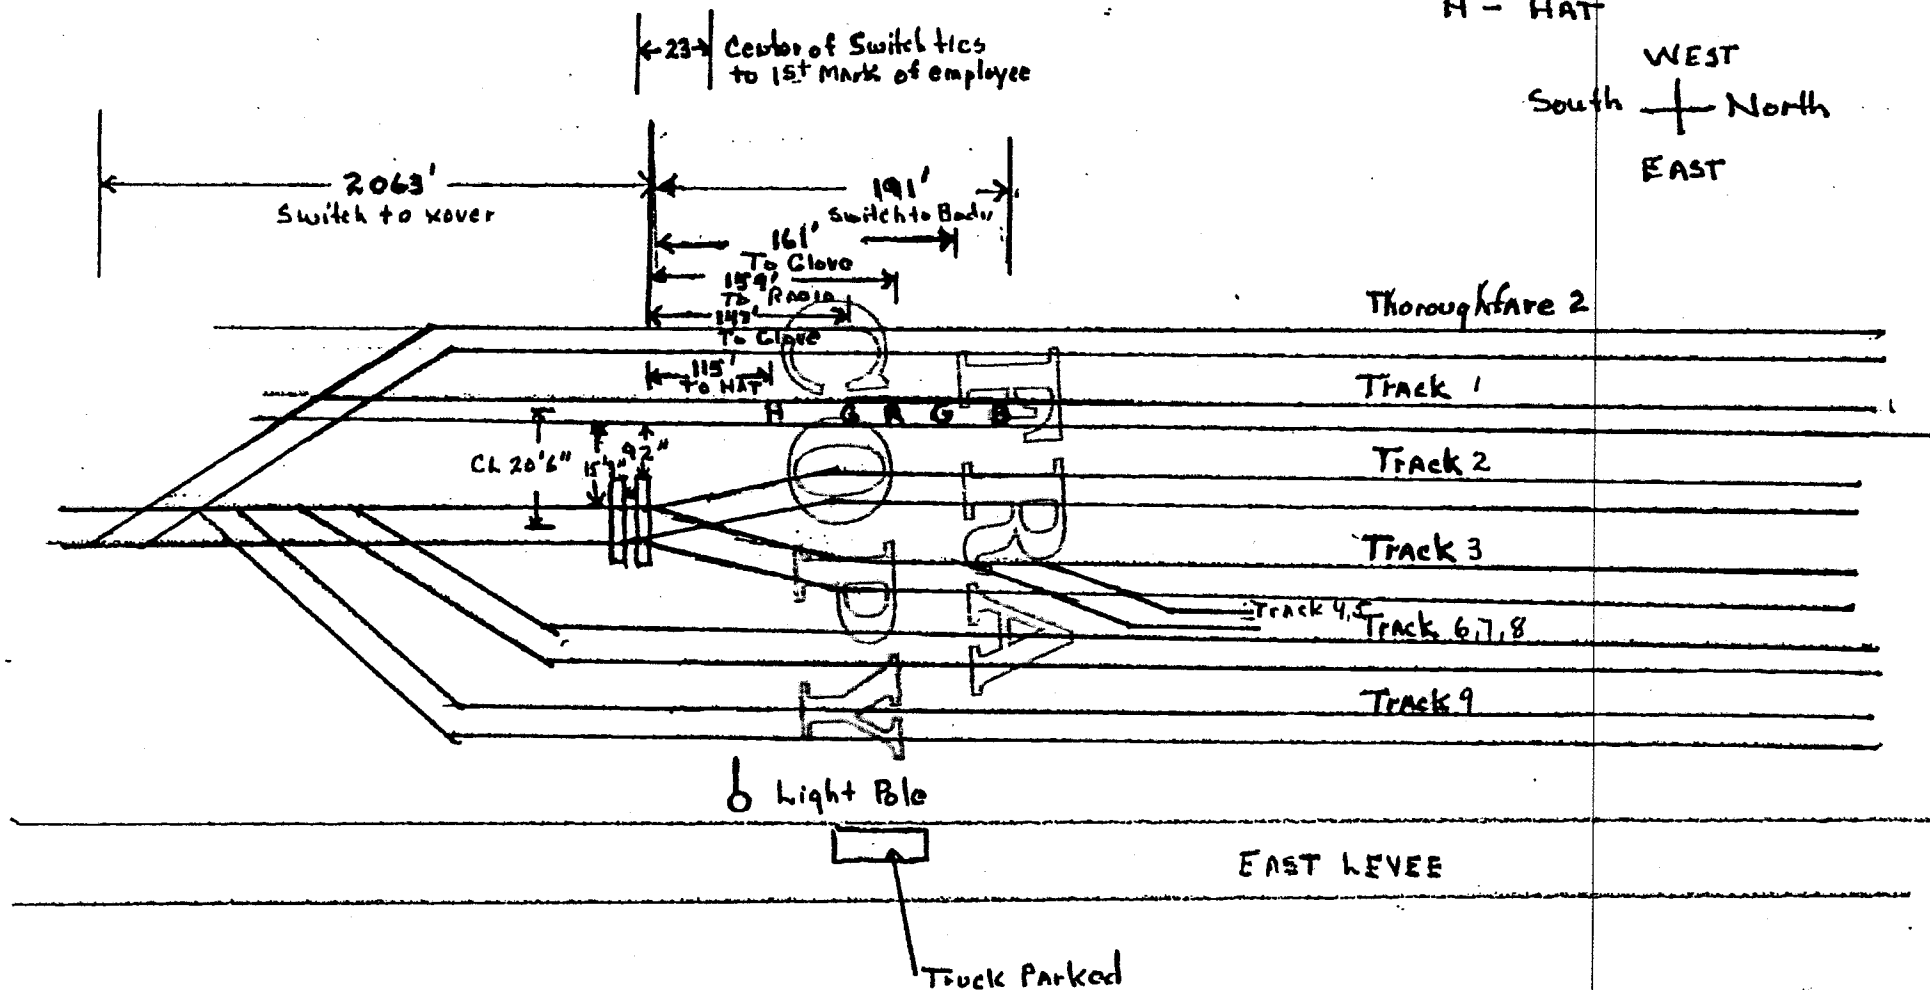
The tracks in the south yard extended northward and southward and were numbered One through Nine, beginning from Thoroughfare No. 2. The yard lighting in the area of the accident consisted of a single pole light, east of the accident area, and located between Track No. 9 and the East Levy Road.
